5.4 BUILDING INNOVATIONS

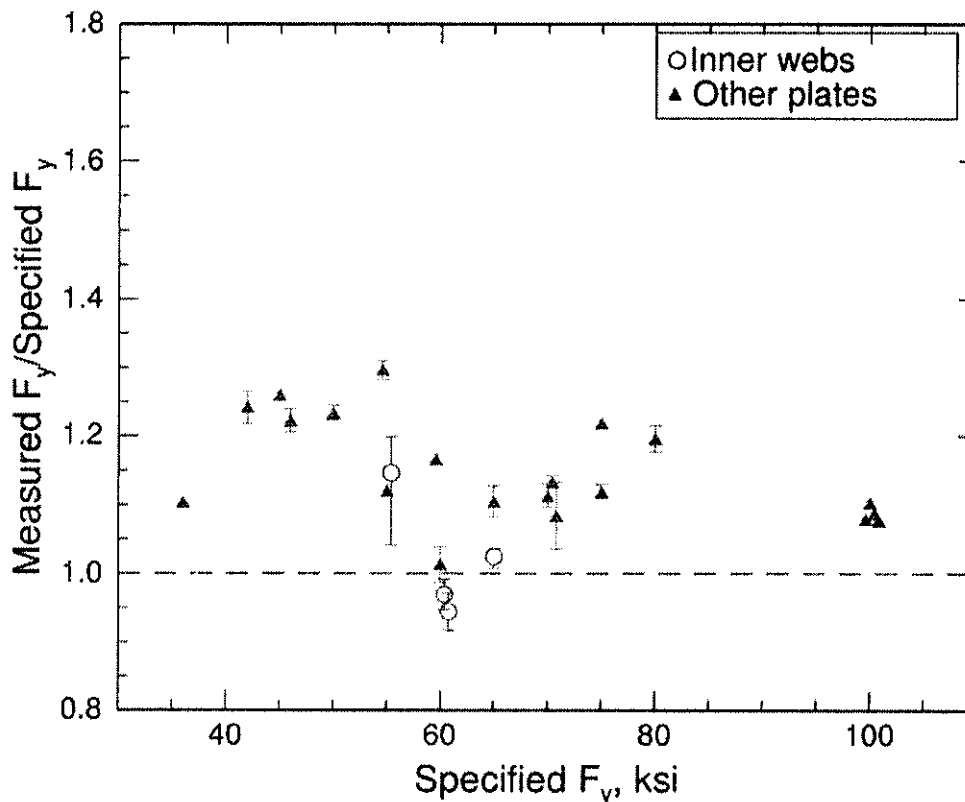
Figure 5-4. Ratio of measured yield strength (F_y) to specified minimum yield strength for steels used in WTC perimeter columns.

- Roughly 13 percent of the measured strength values for the perimeter and core columns were at or below the specified minimums (Figure 5–4). The strength variation was consistent with the historical variability of steel strength and with the effects from damage during the collapse of the towers. The measured values were within the typical design factor of safety.

Note: The ratio values less than 1 arose from natural variation in the steel and did not affect the safety of the towers on September 11, 2001. The bars represent maximum and minimum values from multiple measurements.

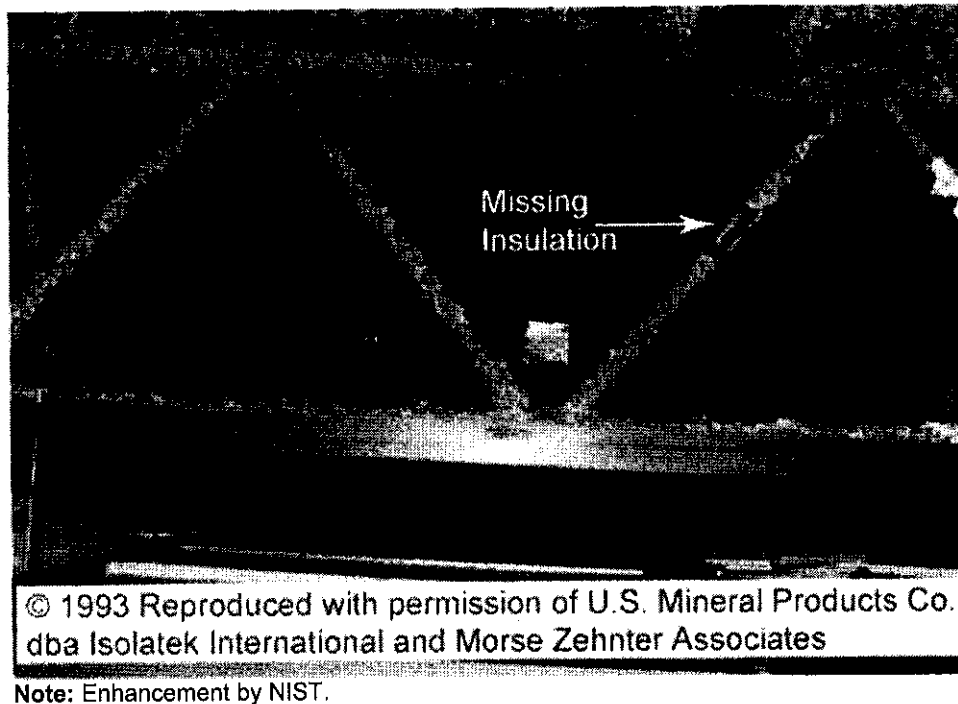
Figure 5-5. Irregularity of coating thickness and gaps in coverage on SFRM-coated bridging trusses.

In 1994, The Port Authority measured the SFRM thickness on trusses on floors 23 and 24 of WTC 1. In all, average thicknesses were reported for 32 locations, and the overall average thickness was found to be 0.74 in. NIST performed a further evaluation of the SFRM thickness using photographs taken in the 1990s of floor trusses on (non-upgraded) floors 22, 23, and 27 of WTC 1 (Figure 5-5). By measuring dimensions on the photographs, NIST estimated the insulation thicknesses on the diagonal web members of trusses. (The thickness of chord member insulation could not be measured.) The average thickness and standard deviation of web members was 0.6 in. ± 0.3 in. on the main trusses, 0.4 in. ± 0.25 in. on the bridging trusses, and 0.4 in. ± 0.2 in. on the diagonal struts. These numbers indicated that there were areas where the coating thickness was less than the specified 0.5 in.

In 1995, The Port Authority performed a study to establish requirements for retrofit of sprayed insulation to the floor trusses during major alterations when tenants vacated spaces in the towers. Based on design information for fire ratings of a similar, but not identical, composite floor truss system contained in the Fire Resistance Directory published by Underwriters Laboratories, Inc., the study concluded that a 1½ in. thickness of sprayed mineral fiber material would provide a 2 hour fire rating, consistent with the Class 1B requirements. In 1999, the removal of existing SFRM and the application of new material to this thickness became Port Authority policy for full floors undergoing new construction and renovation. For tenant spaces in which only part of a floor was being modified, the SFRM needed only to be patched to ¾ in. thickness or to match the 1½ in. thickness, if it had previously been upgraded. In the years between 1995 and 2001, thermal protection was upgraded on 18 floors of WTC 1, including those on which the major fires occurred on September 11, 2001, and 13 floors of WTC 2 that did not include the fire floors. The Port Authority reported that the insulation used in the renovations was BLAZE-SHIELD II.

In July 2000, an engineering consultant to The Port Authority issued a report on the requirements of the fire resistance of the floor system of the towers. Based on calculations and risk assessment, the consultant concluded that the structural design had sufficient inherent fire performance to ensure that the fire condition was never the critical condition with respect to loading allowances. The report recommended that a 1.3 in. thickness be used for the floor trusses.

In December 2000, another condition assessment concluded that the structural insulation in the towers had an adequate 1 hour rating, considering that all floors were now fitted with sprinklers. The report also noted the ongoing Port Authority program to upgrade the fire-resistive material thickness to 1½ in. in order to achieve a 2 hour fire rating.

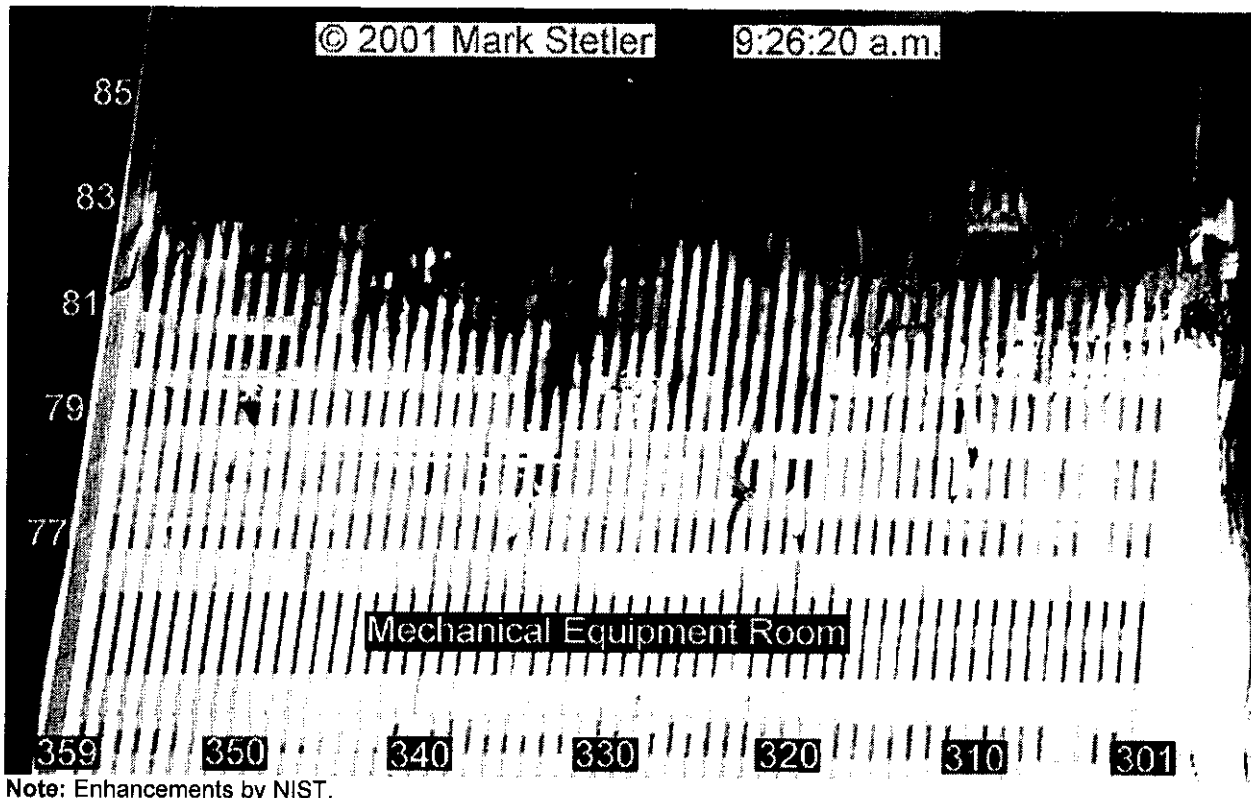
Figure 6–1. 9:26:20 a.m. showing the east face of WTC 2.

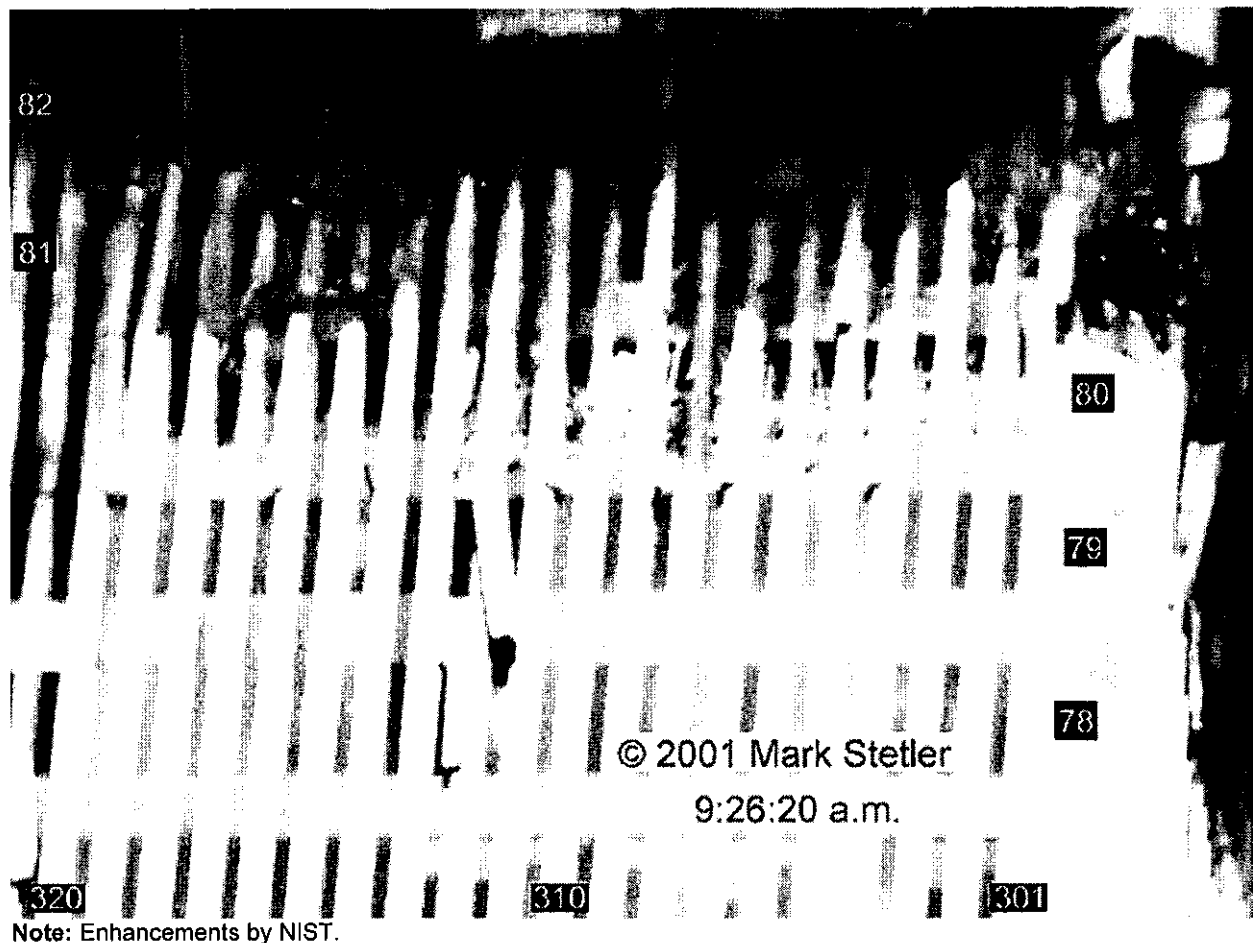
- The locations of the broken windows, providing information on the source of air to feed the fires within.
- Observations of the spread of fires.
- Documentation of the location of exterior damage from the aircraft impact and subsequent structural changes in the buildings.

Figure 6–2. Close-up of section of Figure 6–1.

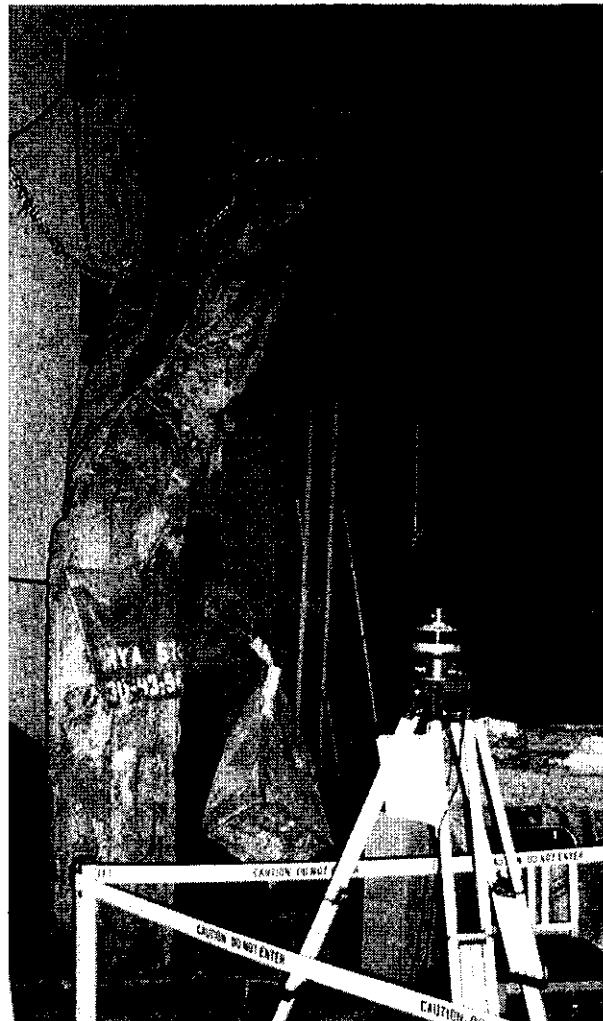
Figure 6–5. WTC 1 exterior panel hit by the nose of the aircraft.

For two of the five exterior panels from the impact zone of WTC 1, the general shape and appearance of the recovered pieces matched photographs taken just before the building collapse. Thus, NIST was able to attribute the observed damage to the aircraft impact. NIST also made determinations regarding the connections between structural steel elements:

- There was no evidence to indicate that the joining method, weld materials, or welding procedures were inadequate. Fractures of the columns in areas away from a welded joint were the result of stretching and thinning. Perimeter columns hit by the plane tended to fracture along heat-affected zones adjacent to welds.

- The failure mode of spandrel connections varied. At or above the impact zone, bolt hole tear-out was more common. Below the impact zone, it was more common for the spandrels to be ripped from the panels. There was no evidence that fire exposure changed these failure modes.
